## Appendix G: Random Inspections

### Field Notes and Pictures

Utility: ComEd      Investigators: J. Stutsman & J. Spencer

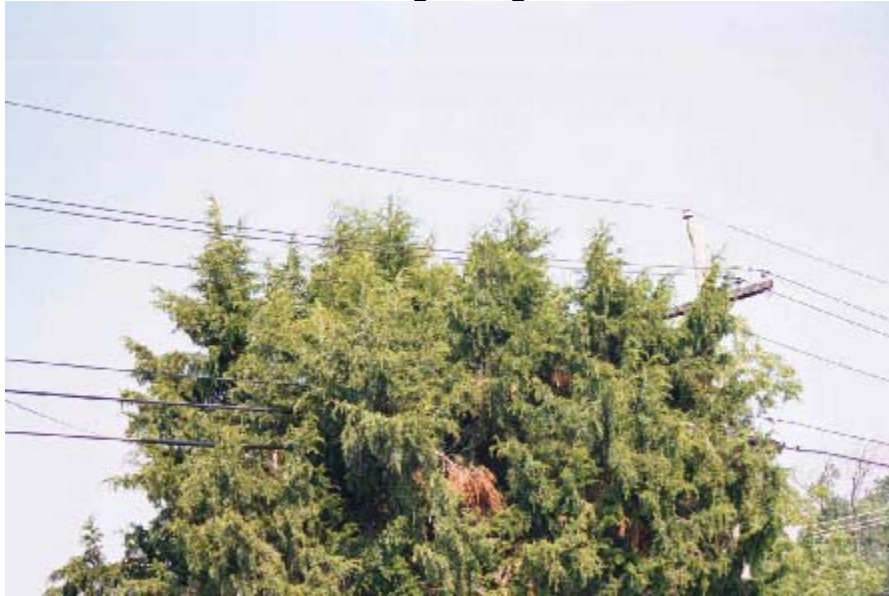
### Picture G1

Primary in Cedar tree south east corner of Aberdeen St. and 16<sup>th</sup> Place in alley in Chicago Heights

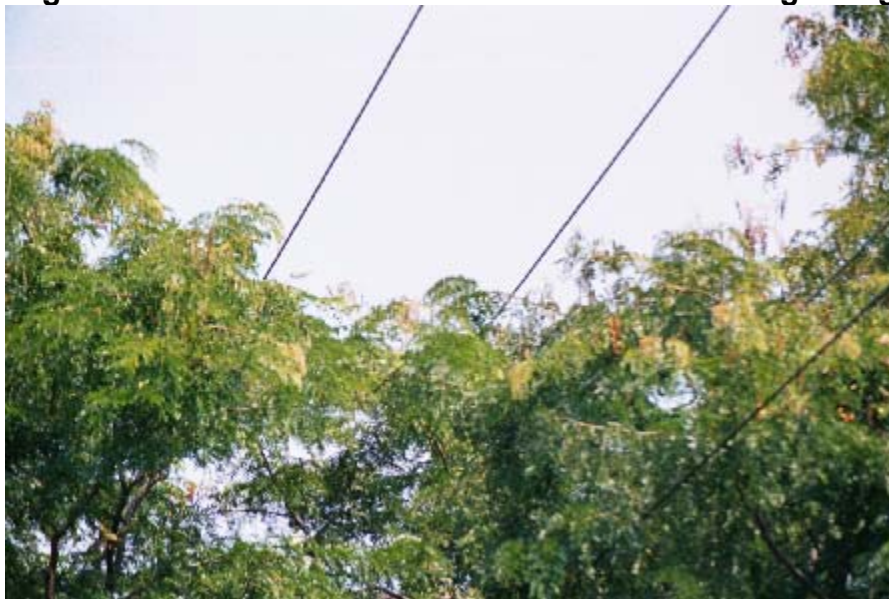
### Picture G2

Bare primary into Locust trees with burning on branches 10-30 yards south of Chicago Rd. and Greenbriar Ave. intersection in Chicago Heights

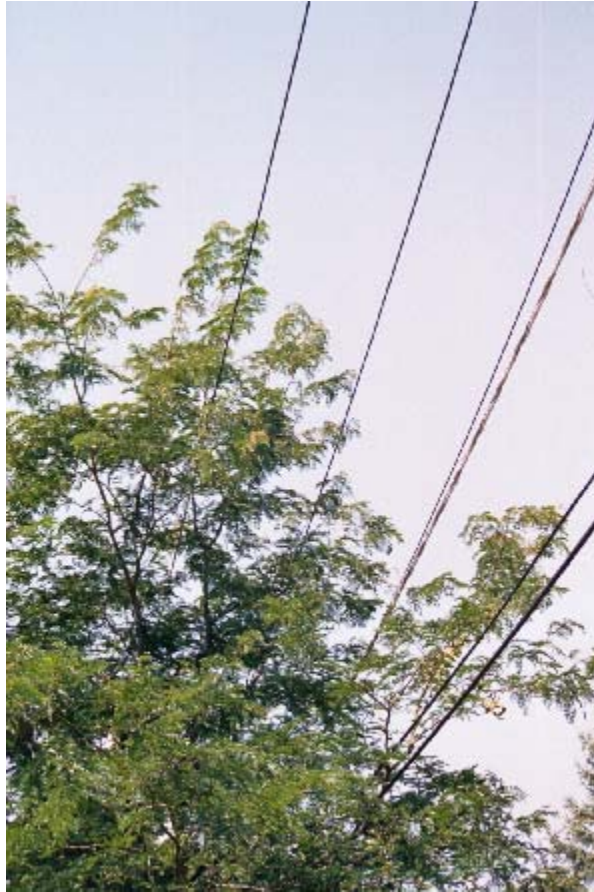
**Picture G3**

12kV	Homewood	8/7/01	Tree contact, insulated primary (tree wire) through tree 200 yards east of Dixie and Terrace Rd. -- See Picture G3
12kV	Homewood	8/7/01	Tree contact, bare primary (looks like copperweld) in Poplar trees between Martin and Dixie on Heather Rd. near 18529 Martin Ave. on south side of property*
12kV	Harvey	8/7/01	Tree contact, branch laying on insulated primary (tree wire) in alley also <u>missing ground wire</u> 100 yards south of 157th St. between Myrtel and Loomis *

**Insulated primary through tree 200 yards east of Dixie and Terrace Rd.  
intersection in Homewood**

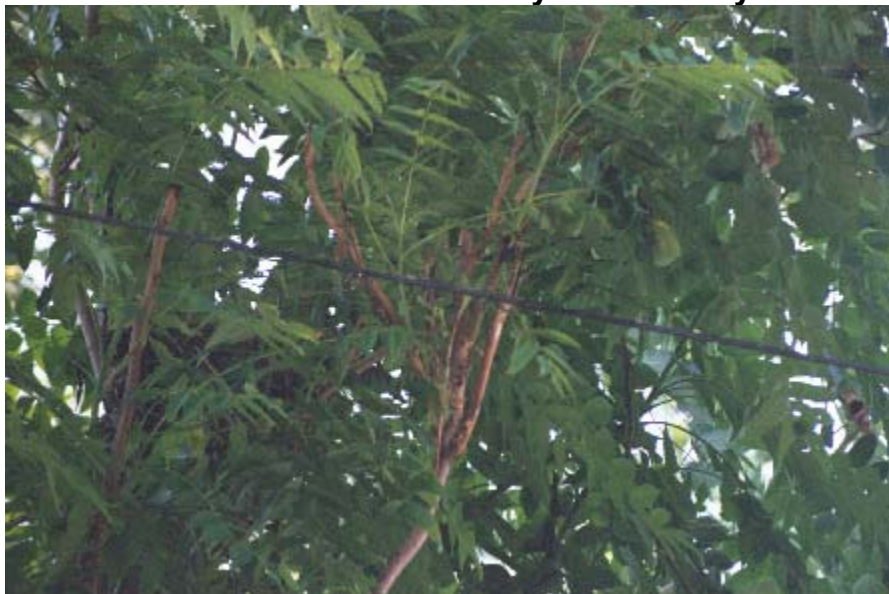
**Picture G4**

12kV	Harvey	8/7/01	Tree contact, primary (looks like weatherproof CU) brushing against tree in several places in alley 50 yards north of 156th between Vine Ave. and Myrtle – See Picture G4
12kV	Rockford	8/9/01	Tree contact, 2821 20th St. along Reed Ave. side – all three phases of bare primary into top of tree with burning*
12kV	Rockford	8/9/01	Tree contact, 1119 20th St. broken tree branch supported by neutral*
12kV	Rockford	8/9/01	Tree contact, 815 20th St. primary into Sycamore tree with burning of leaves*
12kV	Rockford	8/9/01	Tree contact, 3503 Corbridge -- east of Fairview in right-of-way at street side, insulated primary (tree wire) with trees in north phase and switches and with burning in tree *
12kV	Rockford	8/9/01	Tree contact, 3503 Corbridge -- switch operation is hindered by tree (east side of Fairview in right-of-way) – See Picture G5
12kV	Rockford	8/9/01	Tree contact, right-of-way between Corbridge and Rural St and west of Fairview -- opposite side of Fairview above – insulated primary (tree wire) into Evergreen tree and disappears. Burn marks visible on tree wire – See Picture G6

**Primary brushing against tree in several places in alley 50 yards north of 156<sup>th</sup>  
between Vine Ave. and Myrtle in Harvey**

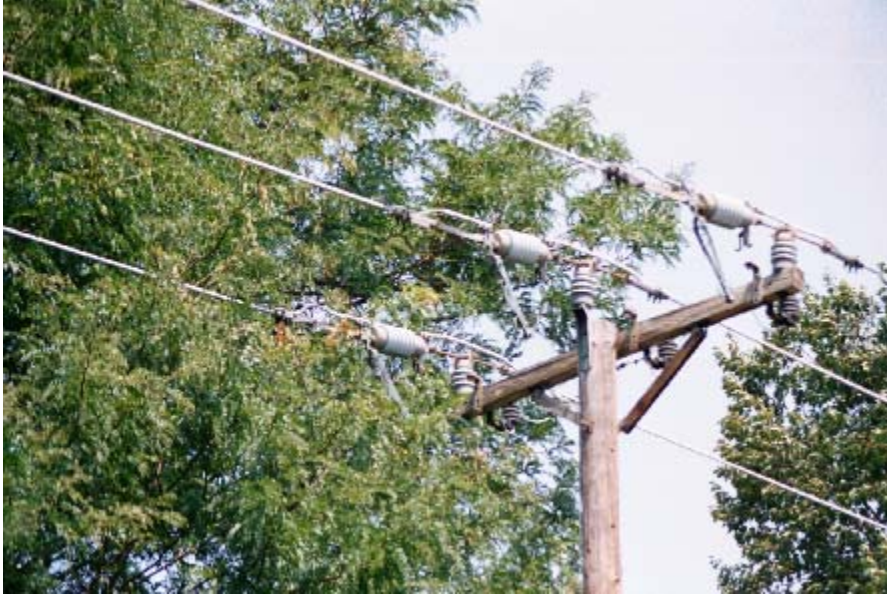
Picture G5

Tree contact in right of way behind 3503 Corbridge near east side of Fairview – note that switch operation is hindered by tree, in Rockford

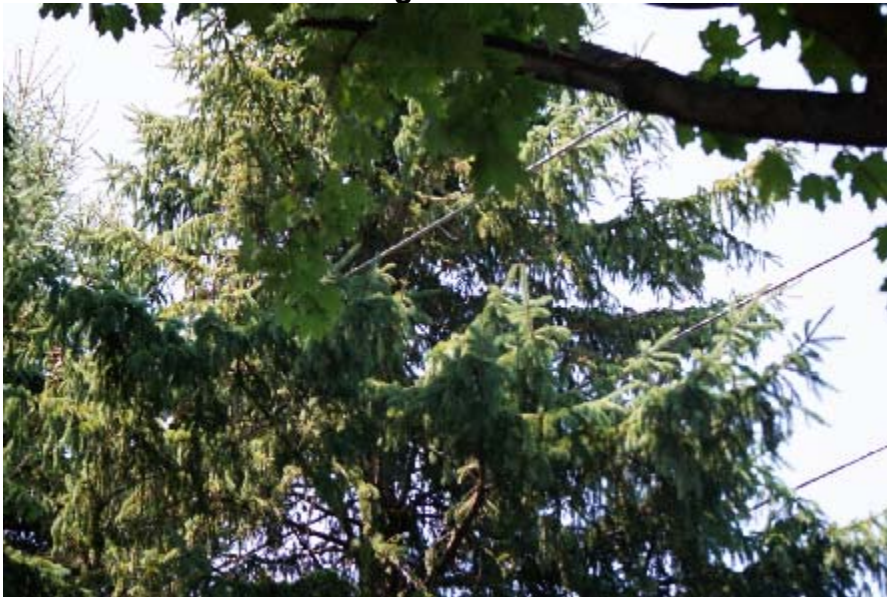
Picture G6

Primary disappears into evergreen in right of way west of Fairview and south of Corbridge in Rockford

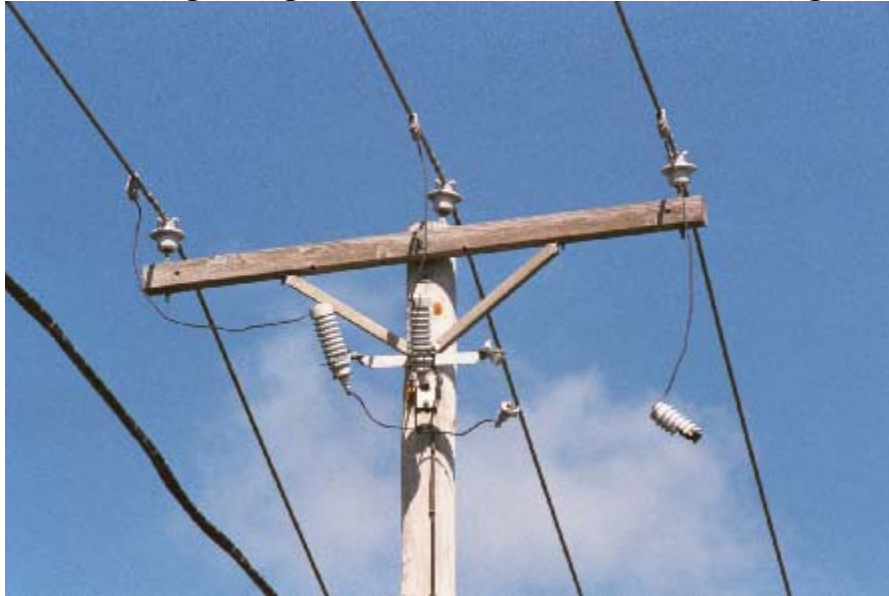
Picture G7

Broken lightning arrestor near 302 Center St. in Elgin

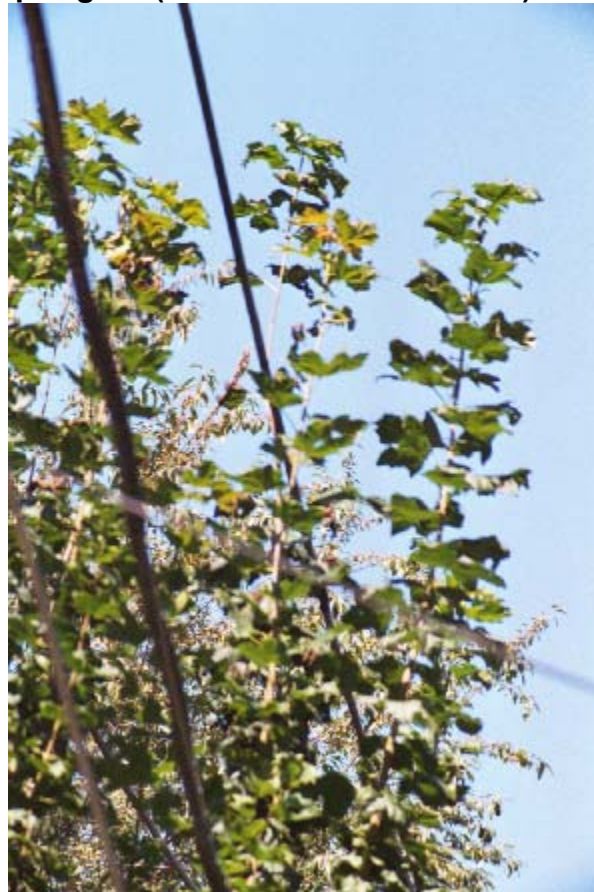
Picture G8

Slow growth hard Maple with growth 2-3 feet above phases in alley behind 1028 N. Spring St. (south of River Bluff Rd.) in Elgin

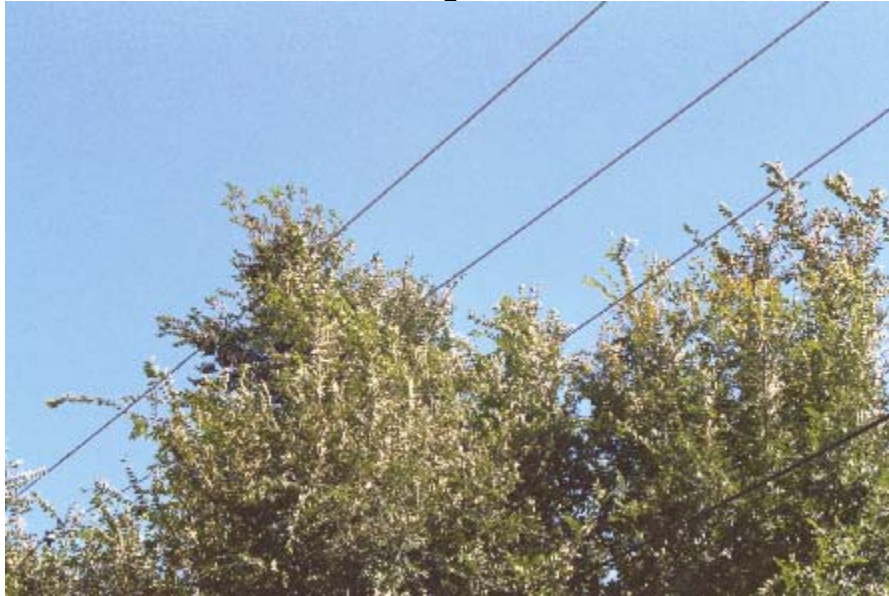
**Picture G9**

**Insulated primary through tree with burning on primary and tree at 819 Bent St. in Elgin**

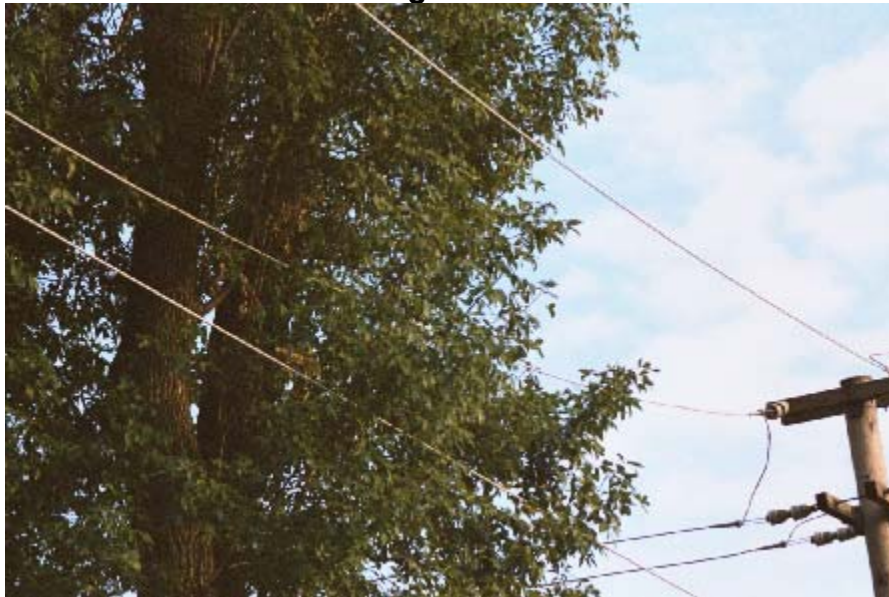
**Picture G10**

**Insulated primary with field side through hardwood tree with burning in tree at 241 or 231 S. Evergreen Ave. in Kankakee**
